Case Study

Lifetime Extension against Minimum Downtime and Cost

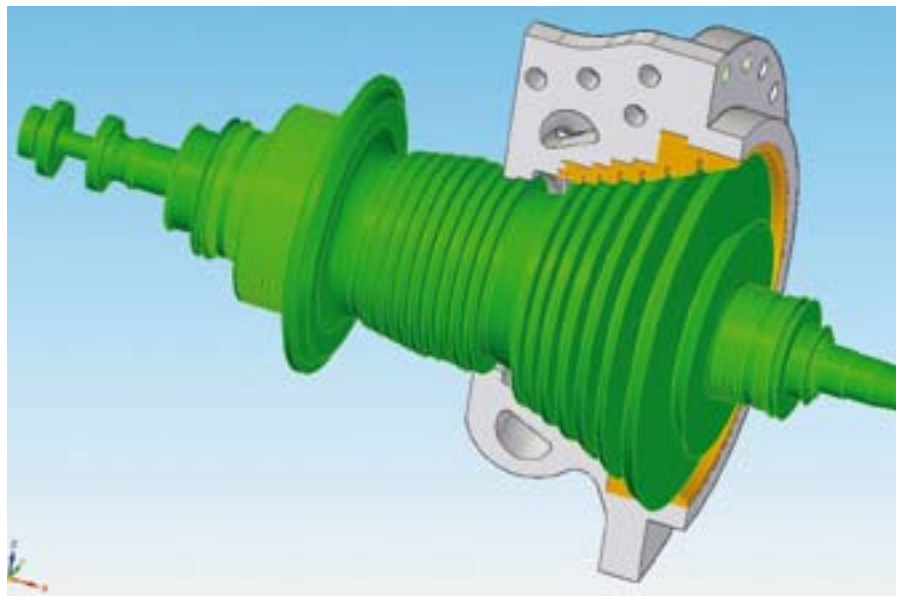
Turbine 3D model.

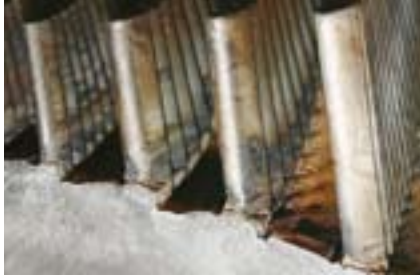
The initial inspection showed that the years of continuous steam erosion were taking their toll on the steam path of the last 7 stationary rows. Whereas the stationary blades remained relatively unscathed, the spacer blocks in-between the blades, and the casing base material were suffering heavily from the higher moisture contents in the steam.

The reason for this erosion rate is that in the 1960's it was more economical to manufacture blade and feet separately, and as in this case from two different materials. The spacer blocks and casing made of a lesser grade steel were simply not suitable to resist the continuous erosion attack. In evaluating the Phase 1 inspection results Sulzer Repco concluded that there was no imminent risk of blade failure, and in agreement with the customer, the turbine was

Stationary blade erosion.

Considering these possible complications Sulzer Repco envisaged a feasible repair proposal, which avoided the complications. The philosophy behind the proposed repair was to remove the casing with its damaged blade grooves, out of the critical path of the repair. This could be accomplished by pre-manufacturing a blade insert complete with new blades. The big advantage of this approach was that the blade root dimensions would not be dictated by the casing's slot dimensions, and therefore could be pre-manufactured. The grooves can be machined in the insert and adjust-

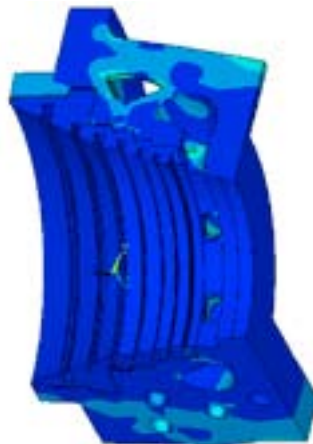
Vain carrier.

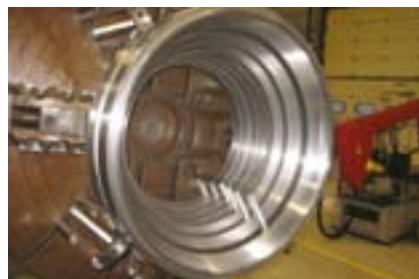
Manufacturing of carrier..

A production drawing for the machining of the blade insert was generated,

and the complete blade insert was manufactured in the Sulzer Repco machine shop. Before removing the blade carrier from the lathe all blade root fits were checked using a gauge block and blue print check with a dummy blade, ensuring a perfect fit on assembly.

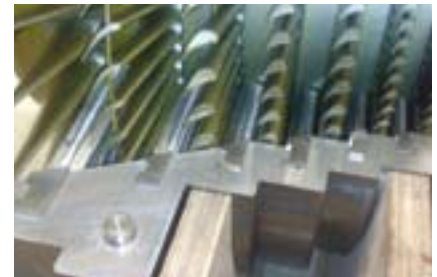
After loading the blades the blade insert was mounted on a stationary test stand together with the rotor in order to check all axial and radial blade fits. Concluding that only minor diametrical modifications on blade tips were required, the blades were

Checking of blade clearances before finalizing..

permanently locked and machined flat with the insert split line.

To finalize the manufacturing process the necessary diameter corrections were made by precision grinding. An inspection report containing all relevant data was presented to the customer for evaluation and approval.
