# Case Study

## Final Stage Blade Modification Extending Lifecycle

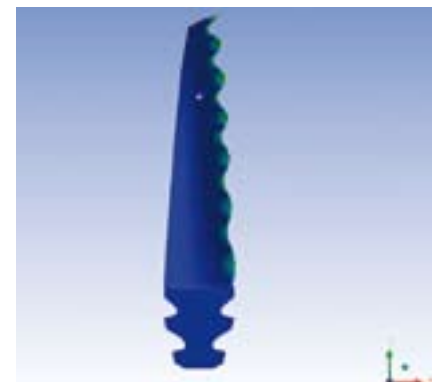
mined two crack initiations located at the blade hole for damping wire and trailing edge. To support the evidences found on metallurgical analysis, stress analysis was then performed. This determined the stress level on the blade and damping wire due to centrifugal force. This analysis was conducted using finite element software. The blade was scanned and measured using portable CMM to define the blade profile prior to modeling in finite element program. The result indicated the maximum stress at airfoil at blade hole for damping wire area is beyond the yield strength of the blade material, and was consistent with the finding on the metallurgical examination.

Finite element analysis of the blade.

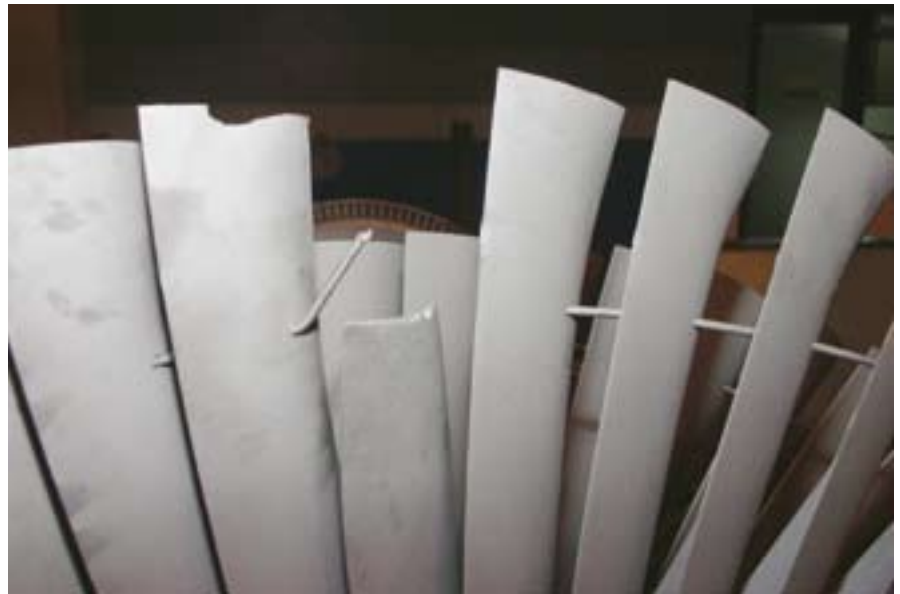
In early August 2007 Sulzer Hickham Indonesia was contracted by an international nickel production company located in South Sulawesi to perform a complete inspection and repair on their 28 MW steam turbine rotor. The unit was reported as having excessive vibration. Further field inspections found that one of last stage blades and the damping wire were broken. The customer requested Sulzer Hickham Indonesia to investigate the root cause of the failure and modify the blade to extend the lifecycle.

Incoming condition of the last stage blades.

yses results, it was concluded that the root cause of the failure was the low safety factor of the damping wire. Once the damping wire failed, the blades were no longer damped and the amplitude of resonance became high enough to start initiating the crack at the trailing edge. A proposal was made to enlarge the damping wire size and blade redesign to shift

The final redesign came to damping wire size enlargement and adding reinforcement at blade hole for damping wire. The finite element analysis of the modified blades and new size of damping wire were conducted to see how significant the stress level would be reduced. The analysis result indicated the stress level at blade air-foil at blade hole for damping wire decreases 38% and the new size of the damping wire had 34% of the stress level of the original one. The natural frequency analysis also indicated no significant change in natural frequencies.

The final design of modified blade was then forwarded to the blade manufacturer for blades production. The new blades were then moment weighed and installed in the unit. The unit is now running at full capacity without any problems.

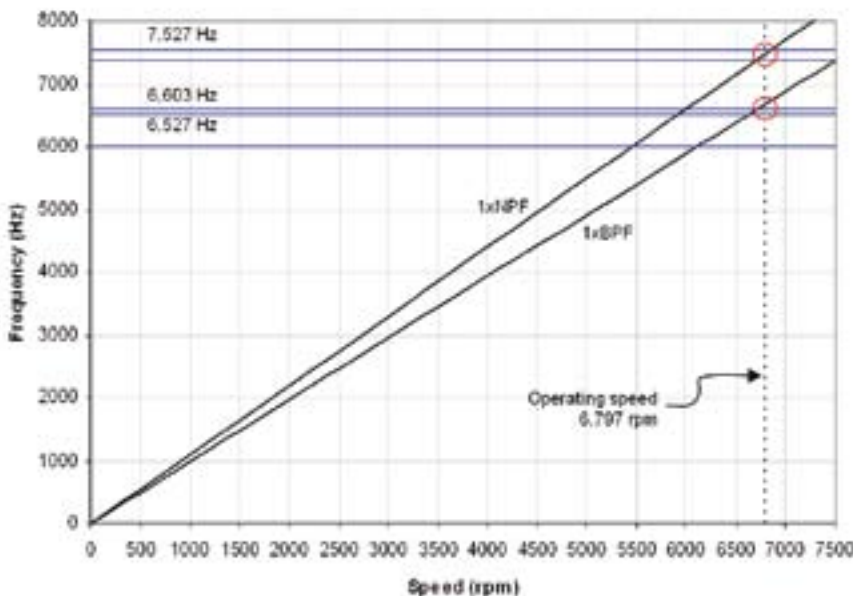
The result of both tests on the blades showed that there is no significant differences with the numerical analysis result by finite element method. This indicates that the natural frequencies obtained can be used for further analysis. The natural frequencies of the analysis was then plotted on Campbell diagrams, to identify significant resonance points. Campbell diagrams depicts turbine speed on the horizontal axis and frequency on the vertical axis. The natural frequencies and the frequencies of exciting forces were plotted. The coincidence of natural frequencies with the exciting forces is used as the definition of resonance. The data was next analyzed at blade pass frequency (BPF) and nozzle pass frequency (NPF). Some intersections were noted.

Campbell Diagram.
