Technical Paper

An Alternative to the OEM for a Frame 3 J Major Overhaul

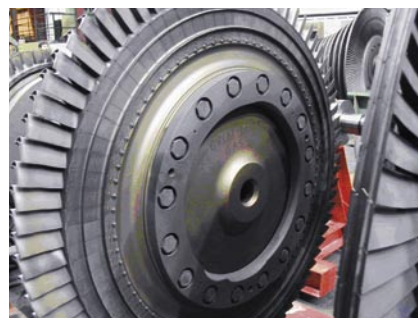
HP rotor of the Frame 3 repaired in our shop

Many of the parts were sent to the Sulzer Hickham USA facility in Texas. This included: both the HP and LP rotors, all combustion components, 1st stage nozzle, 2nd stage nozzle assembly, including all the hatchet blades in the casing, the exhaust frame, starter turbine, gearbox, all bearings, various motors and smaller pumps and the IGV's. All the parts were repaired and coated with Sulzer Hickham USA Hi-Coat materials where necessary. Additionally, an operating speed balance of the HP rotor was performed.

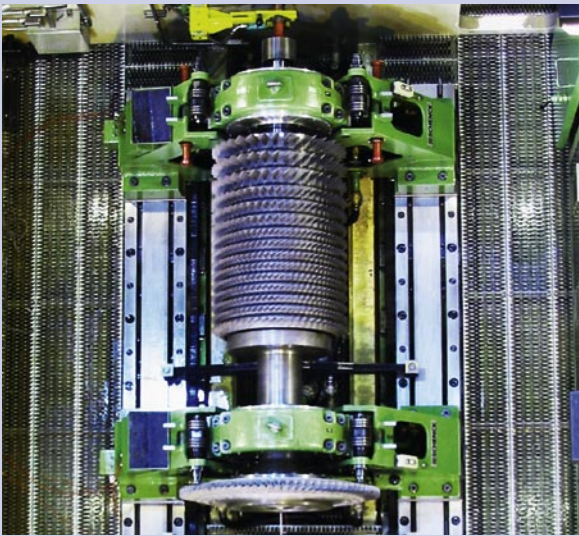
At speed balance of a Frame 3 J HP compressor rotor

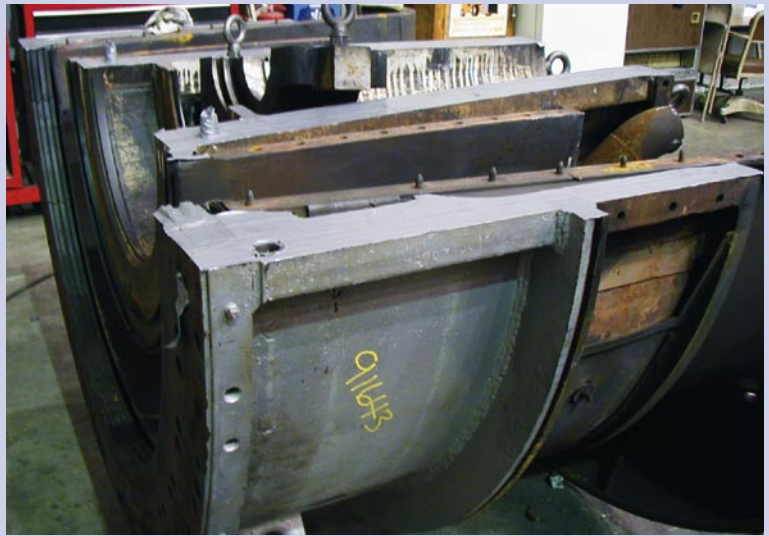
Inspection shows an exhaust frame in a worse shape than expected by the customer

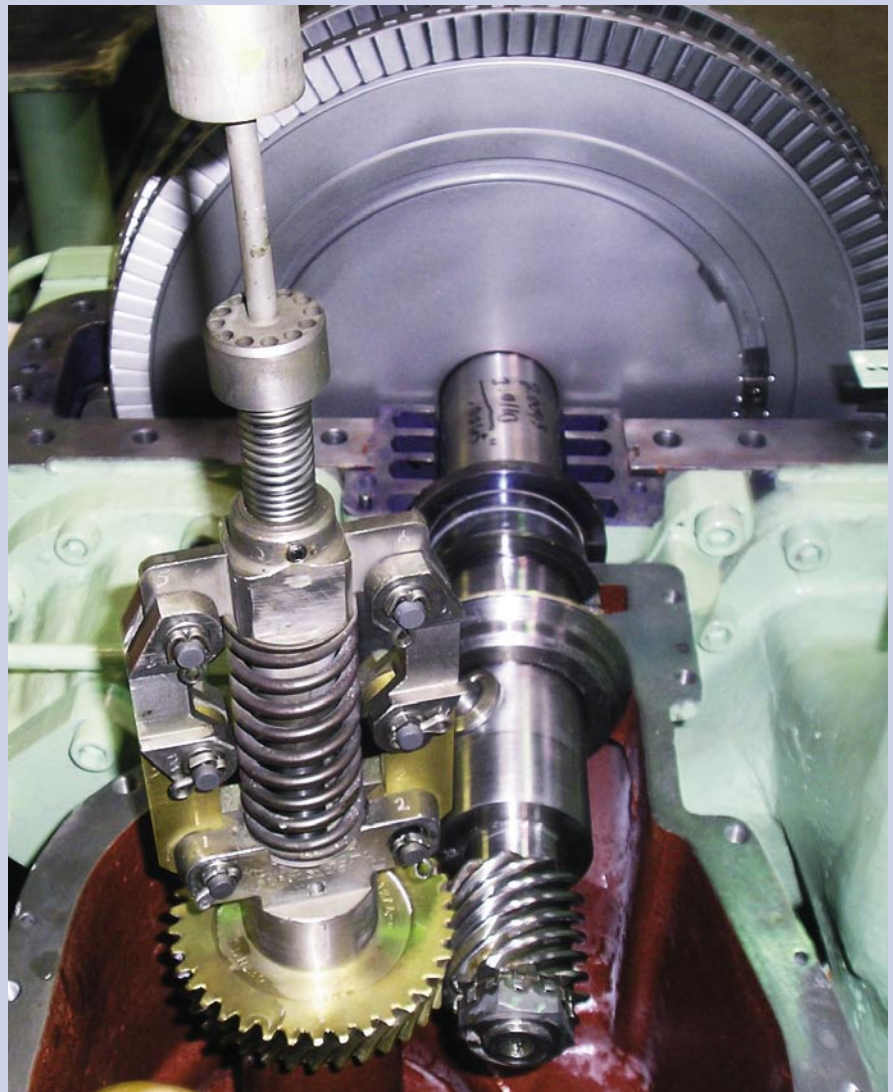
Overhauled starter turbine

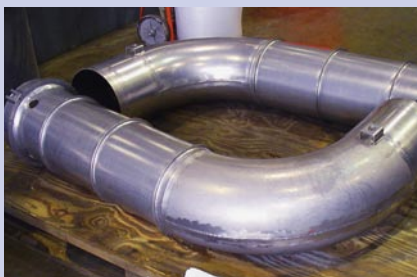
New combustion elbows provided during the course of the job

usual work performed in a major overhaul, it was revealed that the exhaust plenum needed replacement, regenerator work was required, and replacement combustion elbows would have to be sourced.
