Sulzer Repco Overhauls and Repairs a 150-MW Steam Turbine, Including Rotor Straightening

Sulzer Repco received an order to inspect the HP turbine casing of the generator set of a 150-MW steam turbine generator driver which had had a long standstill period.

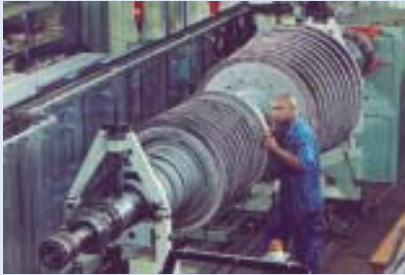
Low balance check of high-pressure steam turbine rotor.

A peening procedure to straighten the rotor was performed, and the resulting run-out was within acceptable limits. After the straightening procedure, the rotor was heat treated (up to 600 °C, which is approximately 10% above steam inlet temperature). Glassbead blasting, NDT, hardness testing, rotor run-out check, and at-speed balancing were then performed.

The result of the straightening procedure and processes produced an overall maximum and final run-out below 0.03 mm TIR at the center of the rotor, which is within the acceptable tolerances.

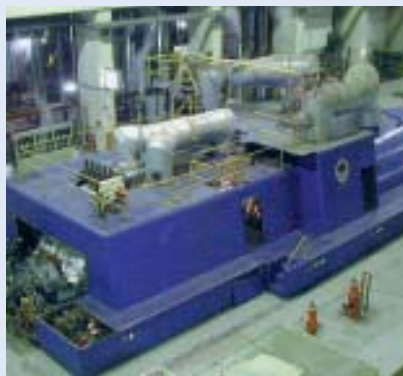
Steam turbine back in operation after overhaul.

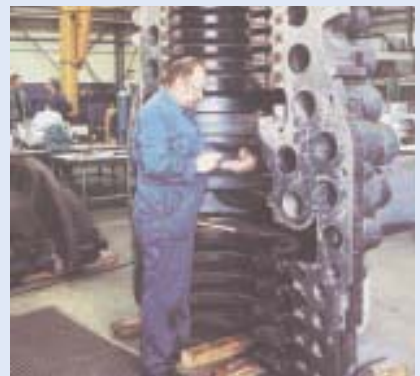
Repair inner casing of steam turbine rotor.

- Machining of new labyrinths in interstage labyrinth housing
- Blueing and contact development, and correction of split lines on the inner casings
- Renewal of special HP joints at inlet admission
