Major Overhaul of a German-Design 100 MW Gas Turbine

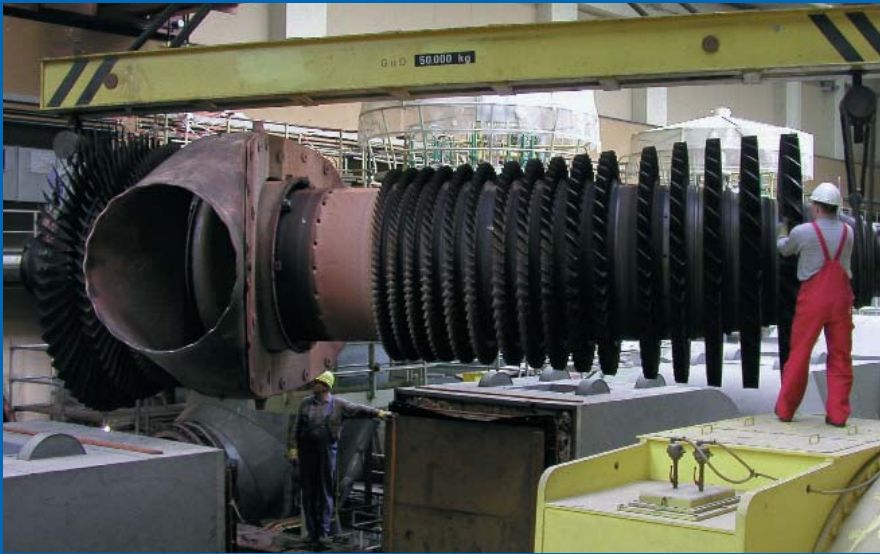
Rotor on crane in machine hall, ready for replacing in turbine casing.

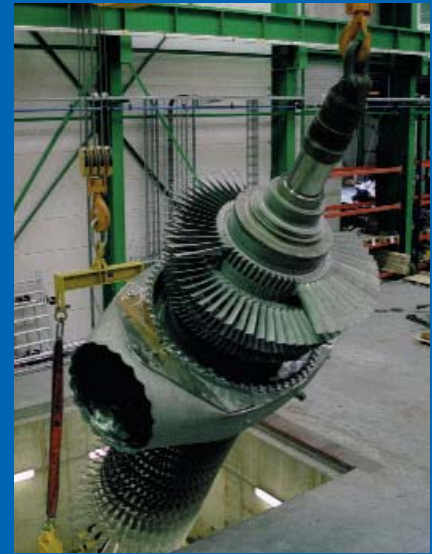
Rotor taken out of the pit in rotorshop.
