Technical Paper

Repair of a Damaged Journal Bearing on a Generator Rotor

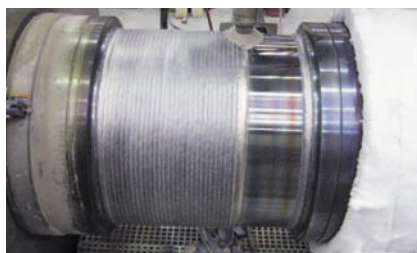
Figure 2: Welding set-up.

After the incoming inspection the rotor was put on a turning lathe and the total journal was machined. After inspection of the surface and the hardness the rotor was brought to the welding equipment (Figure 2). An MPI test was done to be absolutely sure that no more defects were present.

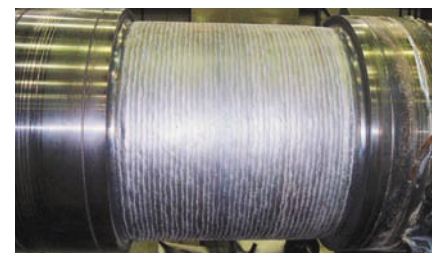
The welding was done by a submerged arc welding process, in combination with two manipulators, one

Figure 3: Journal after welding.

for the rotor rotation, the other for the weld torch translation movement. This process was chosen because of the high quality weld and the high deposition speed (Figure 3). In preparation of the welding process itself Sulzer Elbar needed to find a solution to prevent heat transfer of the journal area to the copper windings and insulation of the generator. A job specific water cooling system was designed and installed on the rotor just next to the welding area and this successfully prevented over-heating of critical areas in the rotor.

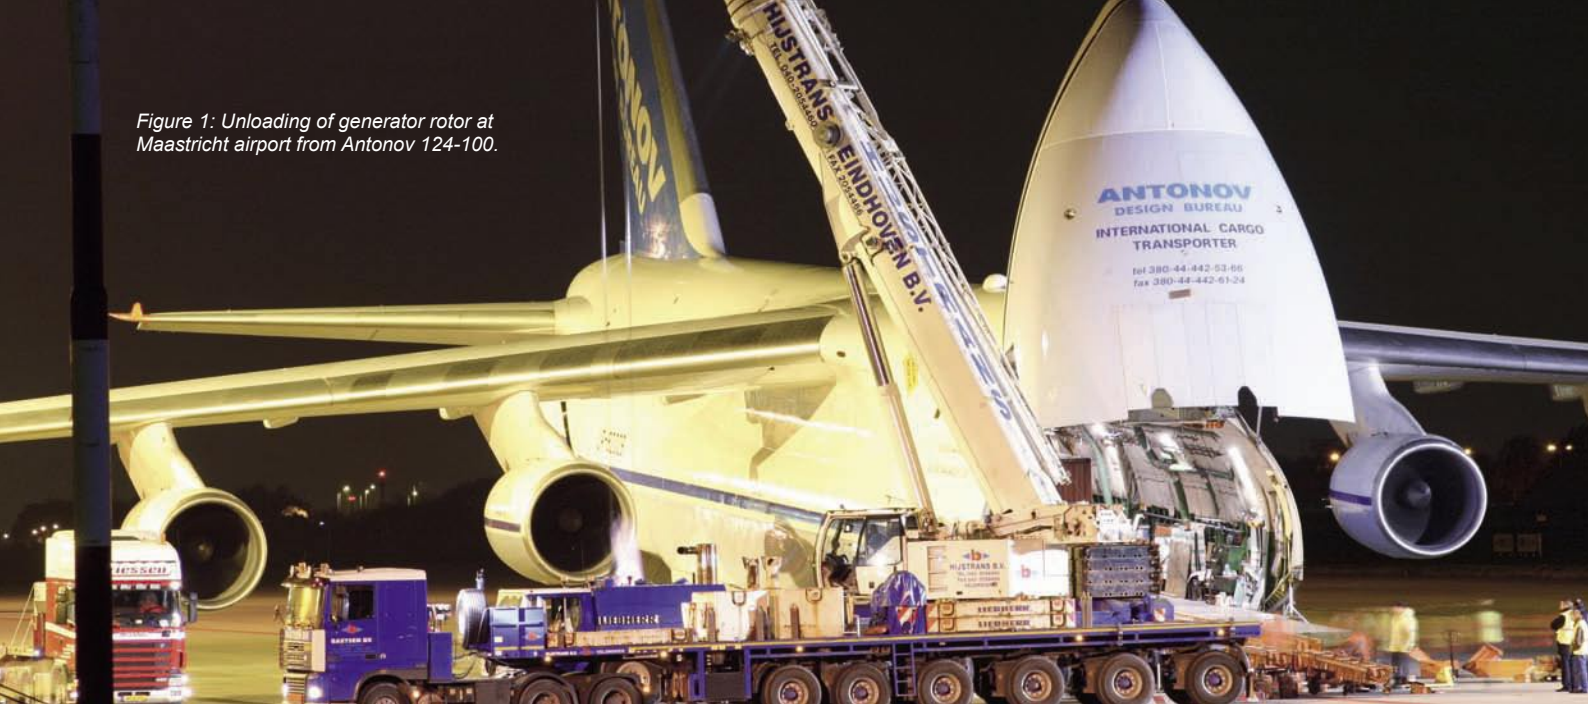
Figure 1: Unloading of generator rotor at Maastricht airport from Antonov 124-100.

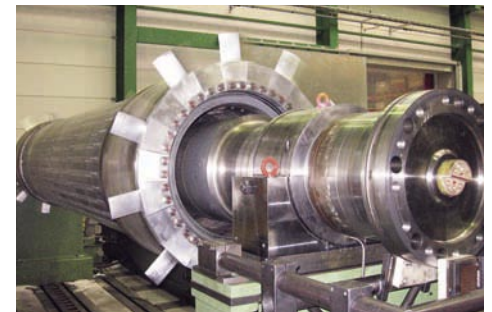
The next step was to machine the welded area and bring it back to its original shape. The only steps left after this were the balance check and the final inspection. For the balancing special bearings were made and during the process the cooling blades were also installed (Figure 4).

Figure 4: LS-balancing of the rotor.
