Technical Paper

Major Overhaul and Repair of an F-Class Turbine

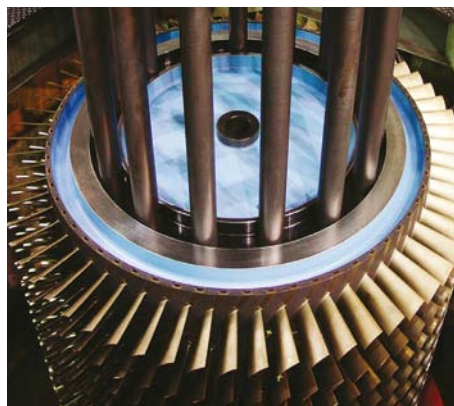
Compressor rotor restack.

Each compressor disc was dynamically balanced, using a state-of-the-art vertical balancing machine designed for compressor disc balancing. The compressor was re-stacked without incident.

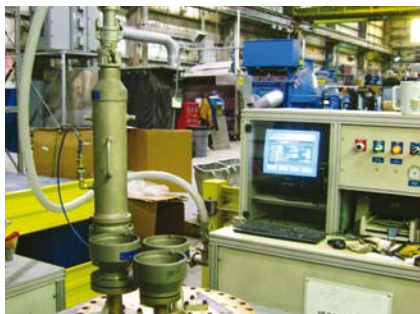
Fuel nozzle flow test.

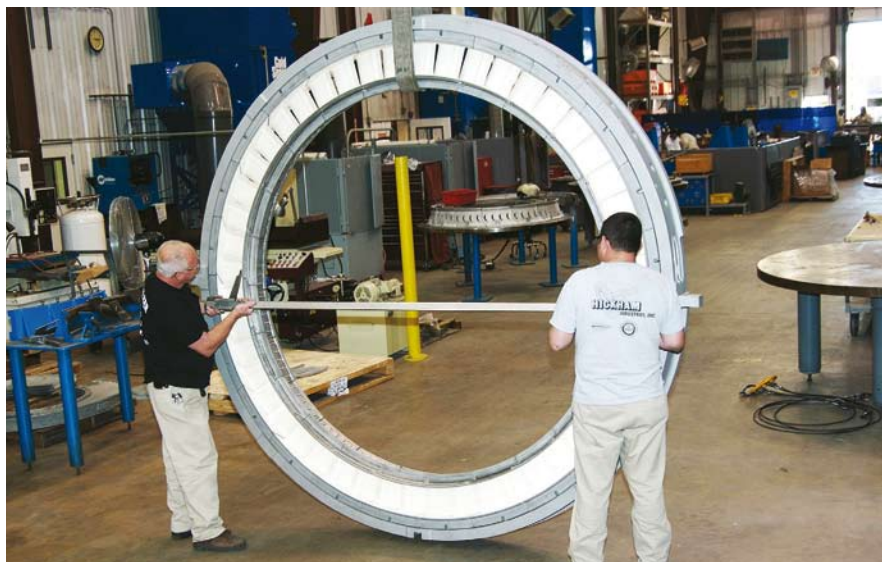
The inspection of the stationary nozzles revealed that they required significant weld repairs. As would be expected, the 1st stage nozzle required the most extensive welding for “crack” repairs and major dimensional correction. Through proper fixturing, welding, and specialized reshaping techniques the dimensions were properly restored followed by major weld repair of the inner and outer walls of the gas path. The pressure and suction sides of the airfoils required extensive weld repairs. Once the segments were complete with the welding and blending process then EDM machines were used to re-establish the cooling holes at precise angles and precise sizes. All cooling passages were then verified to be free and clear of any blockage. The segments then went thru final NDE

Repaired and coated first stage nozzle.

inspection and were certified ready for TBC coating. With post coating QC checks complete the nozzle was then assembled for final dimensional and visual checks. The second and third stage nozzles required slightly less effort than did the first stage, however, all dimensional restoration, weld repair, heat treatment and coating followed the same regimen. All combustion parts were inspected, repaired, and coated.

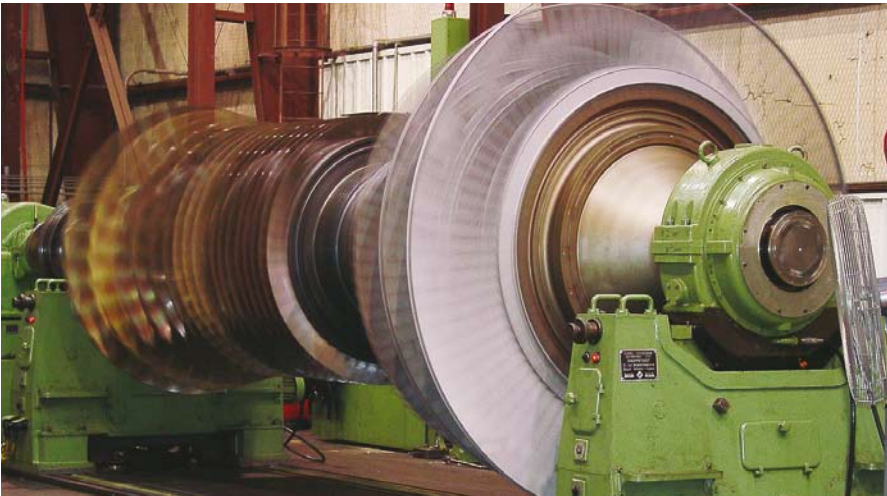
Rotor assembly low-speed balance.

Paralleling the compressor rotor work, the turbine spindle was final inspected, and balanced prior the rejoining of the two rotors for final assembly. Once both sections were “married”, the final inspections and dynamic balance of the assembly concluded this phase of the repair operation.
