Win-Win Situation for Customer and Sulzer

Sulzer Repco was awarded an order for a turnaround on an air separating plant. The work consisted of inspections of the air compressor unit, the oxygen unit and the driver from the pre-pressurizing oxygen unit.

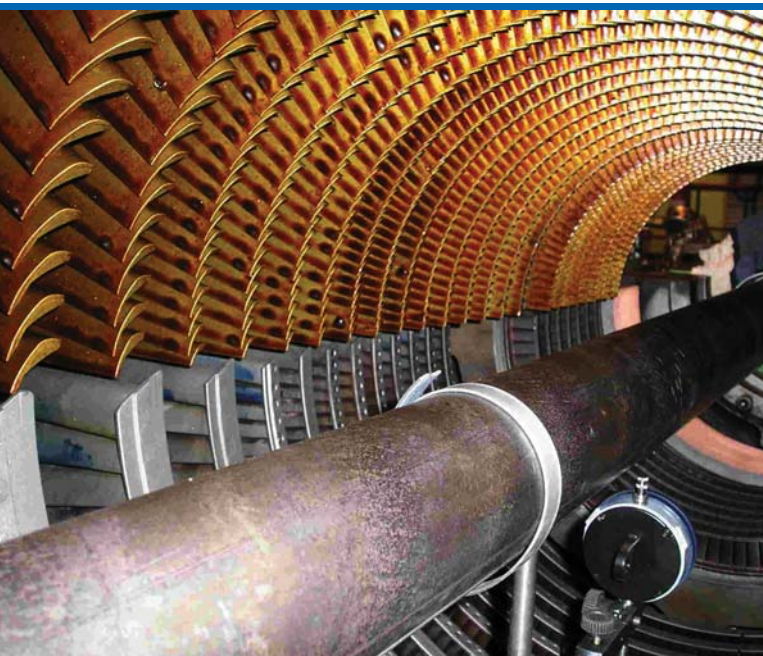
Realignment of modified blade carrier.

Using this method Sulzer Repco was able to perform fast and low risk machining on the casings and carriers and construct simple small parts for the hanging support.

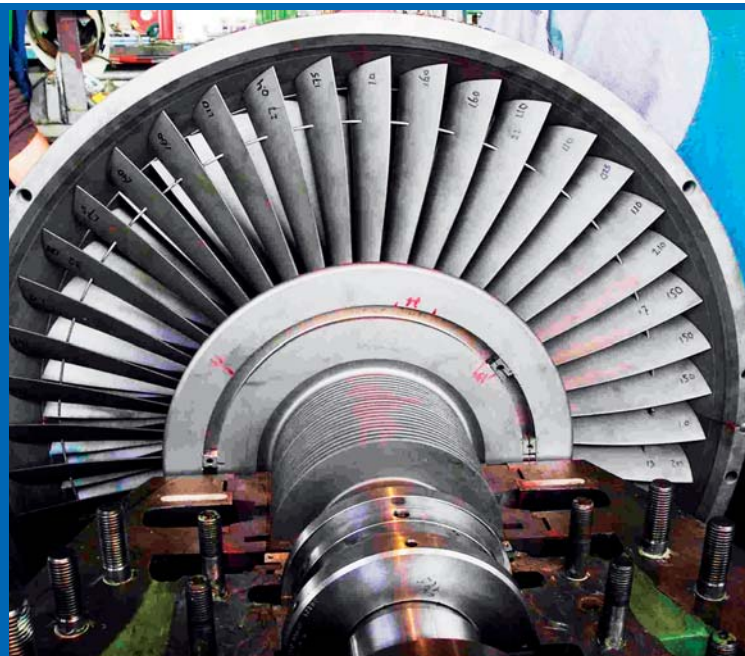
Assembly overview exhaust end.

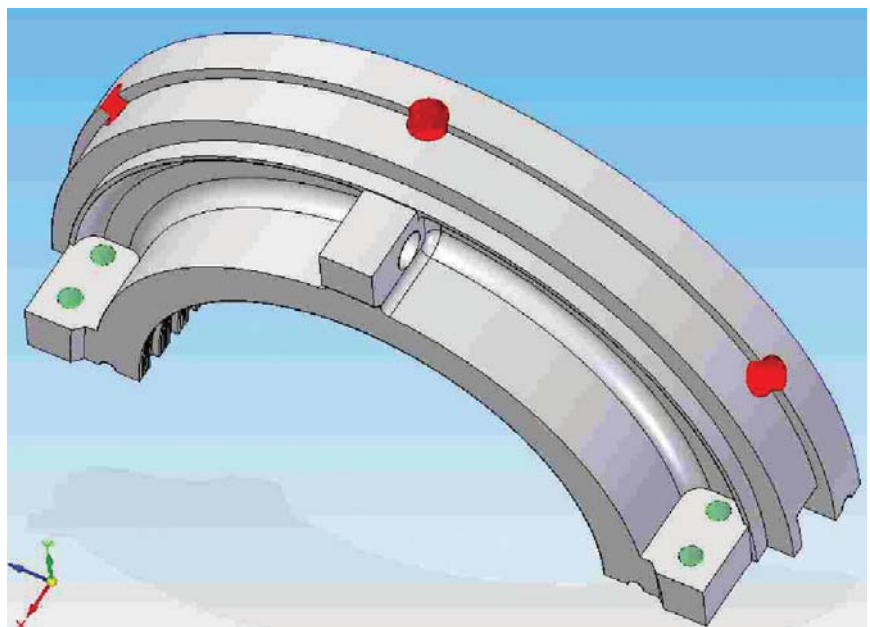
Blade carrier before modification.

casing and carrier outer ring. Due to wet steam and internal leakages, the pins and the carriers suffered erosion,

which caused leakage on the outer casing.

the pinholes and accordingly installation of oversized pins. Due to the risk involved in this kind of repair method, the large machinery equipment needed and the knowledge that the customer is not able to change their steam condition (in order to avoid future damage), Sulzer Repco proposed an alternative.

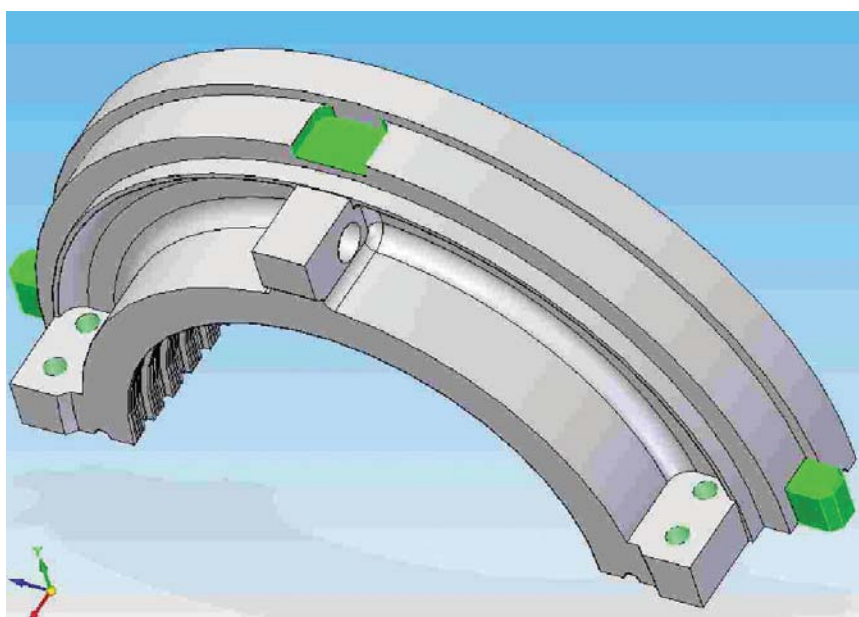
Blade carrier after modification. (a)

- Blocking old pin holes (insert pin and weld)
- Match axial positioning faces.
- Fabricate a separate adjustable hanging horizontal support.
- Fabricate all parts and machining of casings and carriers.

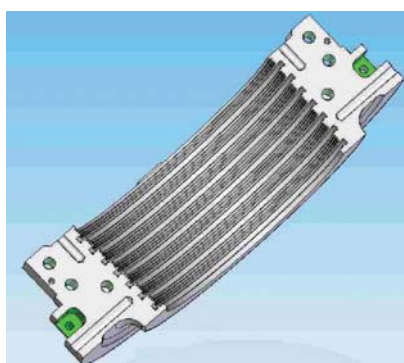
Blade carrier after modification. (b)
