160 MW Steam Turbine Repair Project

Towards the end of 2007, Sulzer Hickham Indonesia was awarded a contract to recondition a 160 MW steam turbine generator set on an emergency basis from a state-owned electrical company located in Medan, North Sumatera. A lube oil failure had caused catastrophic damage to the journals, seals and blades.

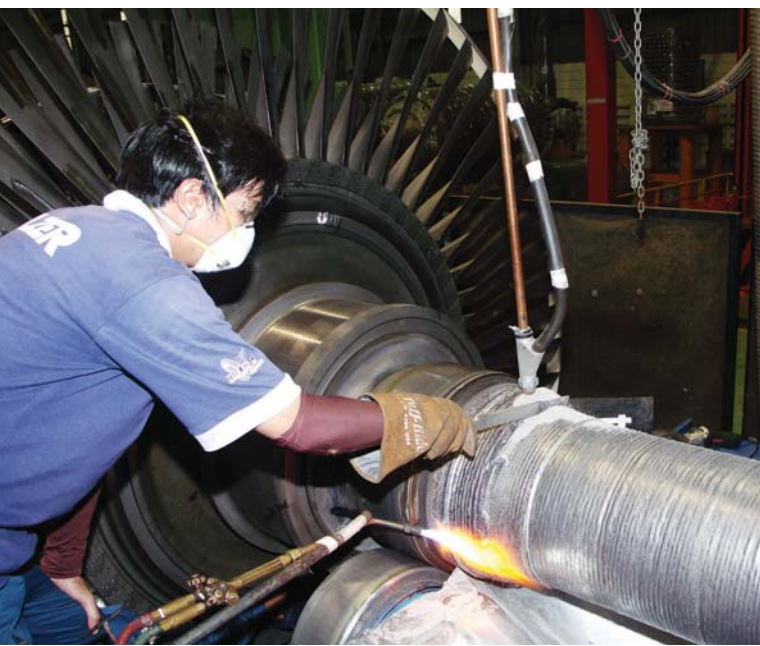
Welding process on the journal of the LP rotor.

Serious damage was also exhibited on the LP and generator rotor with severe rubbings and cracks on the LP rotor journal and generator coupling flange.

that the failure had also caused the turbine rotor to bow very badly.

The LP rotor was straightened and the journals brought back to original dimension and specification by SAW repair process. Due to the LP rotor size - it weighed almost 50 tons - it was necessary to manufacture some fixtures to set it up in vertical position for the stress relief process.

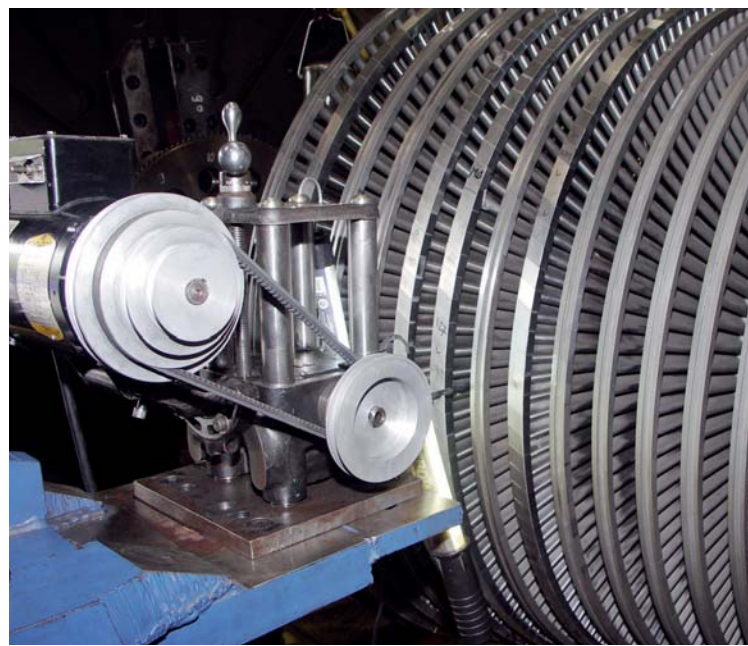
Re-blading works on the HP rotor.

During the site inspection, serious damage was found on the last seven stages of rotating blades of the HP rotor, being 19th to 27th stages. The blades exhibited heavy damage as a result of radial rubbing, other damages on HP rotor including the seal strips.

proposal for repairs with the main scope being: blade replacement on seven last stage blade rows of the HP turbine rotor and blade replacement on the two last stage stator blades of HP turbine, straightening and weld

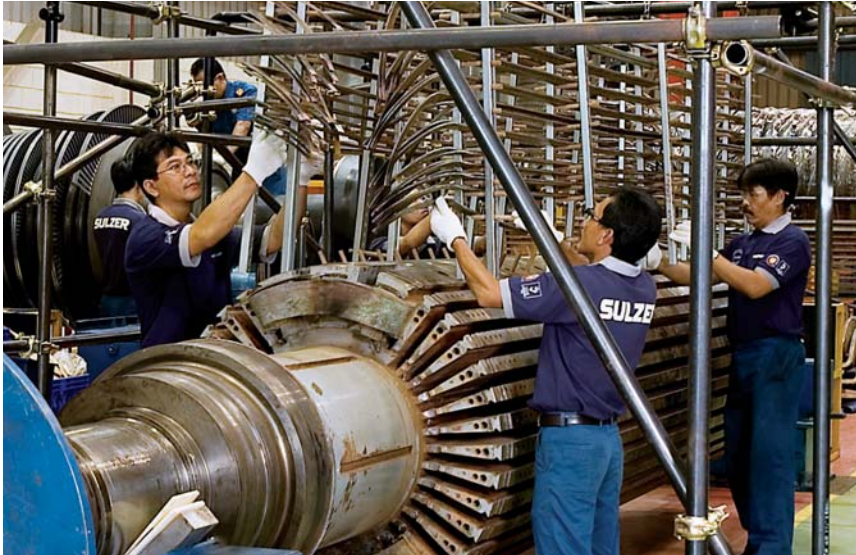
Re-winding works on the generator rotor.

repair of the LP rotor, total seal strip replacement and repairs on the generator rotor coupling flange and complete rewinding.

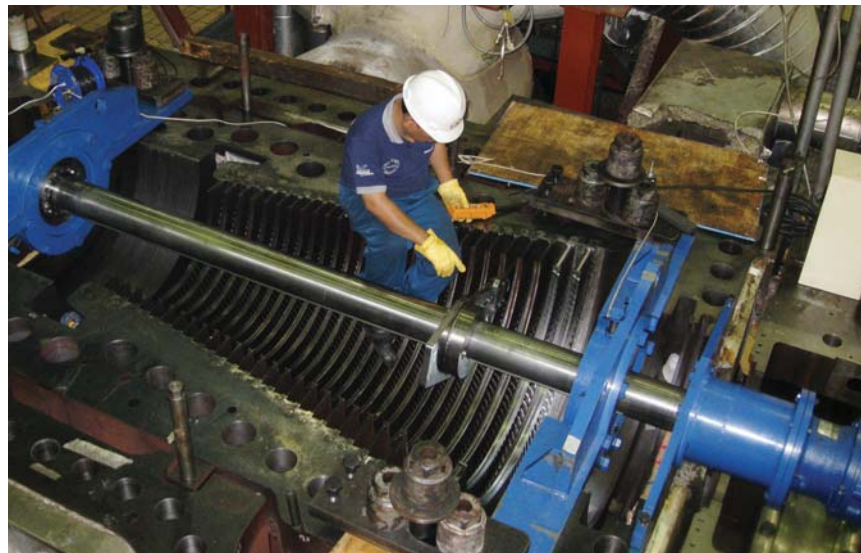
On the stationary components, it was found that the stator blades on 26th to 27th stage of HP unit were in a severely damaged condition, requiring blade replacement and total replacement of all seal strips.

In-situ field machining of HP turbine stationary components.

The replacement of the stator blade and stationary seal strips of the HP turbine and final machining were carried out on-site. For field in-situ machining,

Sulzer Hickham Indonesia designed a portable line boring machine specifically for this application.

weeks. The machine was then delivered to the site and the HP turbine stationary components were successfully machined to target size.
