Case Study

Importance of Startup Vibration Measurements on Turbomachinery

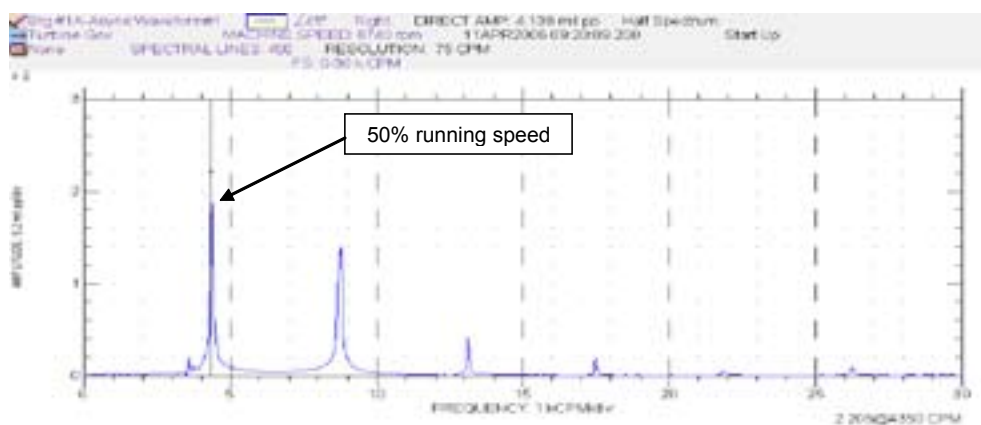
and a high pressure compressor and an expander, high vibration was seen after startup on the governor end bearing of the steam turbine. Examination of the steady state data at full load indicated the highest component of vibration was at a frequency of 50% of the running speed, as seen in Figure 1. This behavior is indicative of oil whirl in the bearing and if left unchecked can lead to destructive vibration levels and failure of the machine. Having identified the problem, a temporary solution of adjusting the oil supply temperature to reduce

Fig. 1: Spectrum of governor end bearing on steam turbine.

the effect of the whirl can be implemented until such time as the unit can be brought down and the bearing modified or replaced with a different design to reduce or eliminate the whirl.

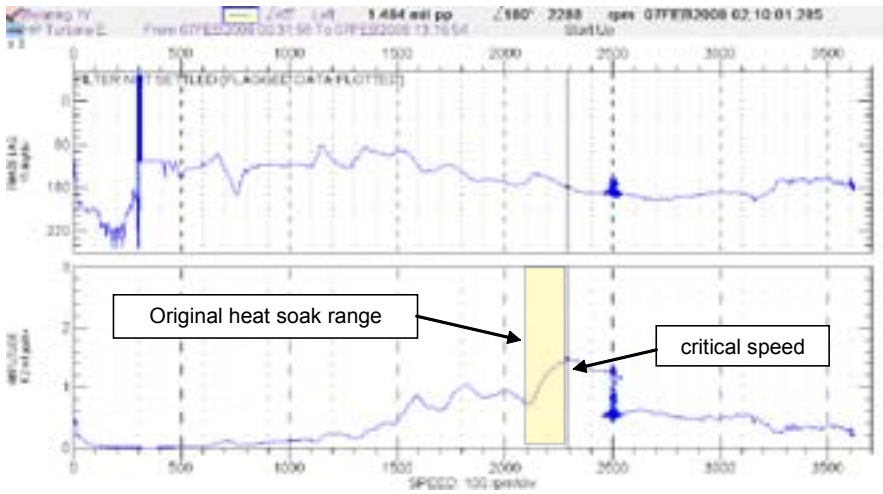
Starting up a large steam turbine/generator train is a risky process in which the shaft heats and expands quicker than the large casings and generator coils. Great care is taken to dwell at certain speeds to heat soak the unit, activate seals and engage the magnetic field. During the startup of a large turbine generator train where the HP turbine had undergone significant rotor and casing rework, excessive vibration occurred while ramping through speed ranges and holding at dwell points that had previously not been an issue. Repair of the HP turbine had resulted in tighter bearing and sealing clearances over the previously worn condition. As seen in Figure 2, the startup vibration data indicated that the critical speed of the HP turbine had moved up into

Fig. 2: Bode plot of HP turbine coupling end bearing showing critical speeds.

the heat soak speed range. Also discovered was that speed was being ramped too slowly to successfully run through a lower critical speed without experiencing excessive vibration. A simple increase of the ramp rate and shift in the dwell zone speed range allowed the turbine generator to start up smoothly and eventually come online and deliver power.

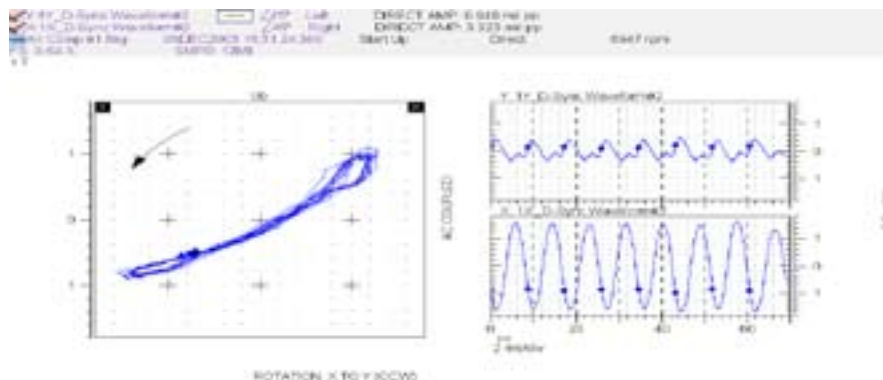
During installation of new or repaired units, maintaining proper alignment of the rotating components of each element in the machine train is critical, as well as ensuring the minimum amount of strain on the casing due to piping connections. Although many techniques exist to ensure that cold setup conditions are within specification, existing pipe strain and the effects of expansion at full load and temperature conditions can be difficult to determine. Figure 3 illustrates the shaft

orbit of the #1 bearing of a gas turbine / pipeline compressor train after the installation of a regenerator. Physical inspections and cold startup vibration data indicated completely acceptable setup and performance, but as load and temperatures increased, excessive vibration occurred. As indicated by the highly elliptical, flat shape of the orbit, the shaft is heavily preloaded in one direction. The preloaded orbit combined with the fact that this behavior was not present prior to installation of the regenerator led to a conclusion that the high vibration was due to turbine casing distortion from a complex series of piping from the compressor to the regenerator and from the regenerator to the combustion cans.

Fig. 3: Shaft orbit plot of gas turbine bearing.

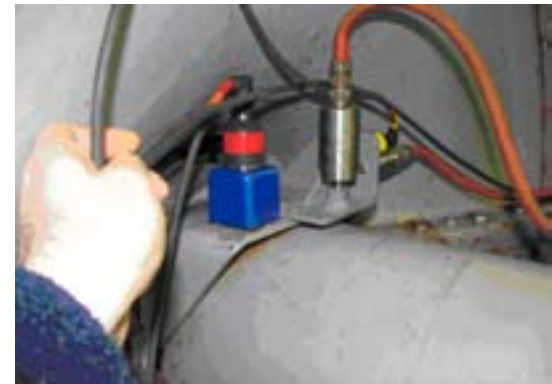
equipment itself. During the startup of a different gas turbine / pipeline compressor train, excessive velocity was measured on the #1 bearing casing. Further examination revealed that the velocity transducer was mounted on an overhung bracket, as shown in Figure 4, and the natural frequency of the bracket was very close to 2X the running speed of the turbine. Relocation of the transducer to a solid surface on the casing resulted in a large reduction in the measured vibration amplitude. Similarly, scratches on a shaft proximity probe surface can falsely indicate high machine vibration, typically showing high levels at 1X running speed and its harmonics. Such was the case on a high speed pinion compressor driven by a large bull gear. The unit was tripping

Fig. 4: Velocity transducer bracket on bearing housing
