# Case Study

## Design Changes Resulting in Lifetime Extension of Gas Turbine Rotor Blades

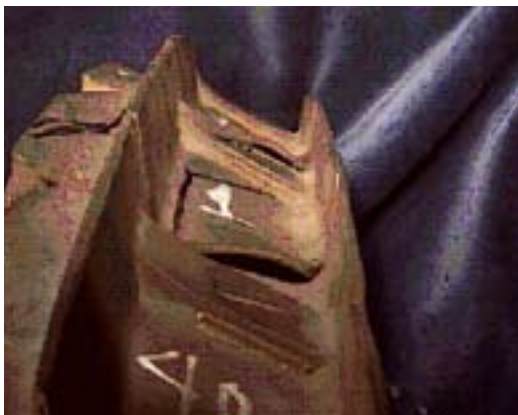
An incoming inspection revealed that among others, the shrouded rotor blades had suffered from creep deflection. Based on the measured deflections, the blades, as shown in figure 1, exceeded the repair specifications and were therefore rejected for further operation.

Fig 1: Creep deflection of shrouded blades.

Due to a combination of the high centrifugal stresses and the operating temperature, creep deflection of the shroud and ballooning develops over time. At a particular degree of deformation, creep damage can no longer be recoverable by heat treatments; hot isostatic pressing or other methods.

After many hours of discussions and brainstorming sessions, Sulzer Elbar developed a potential solution that was discussed with the client. The proposed solution was to remove the defective material (the entire shroud), add material to increase the tip length and modify the existing shroud.

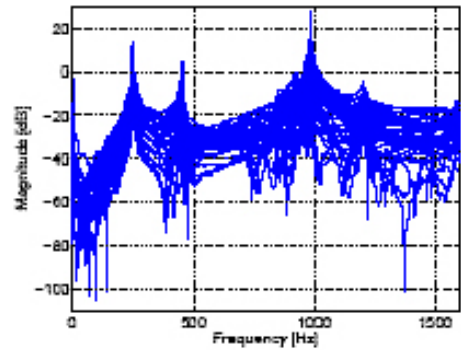
FEM analysis was carried out to calculate the mechanical stresses and to simulate the dynamic behavior of the non shrouded design. The natural frequency of the blade should not interfere with the rotational speed.

Fig 3: Dynamic analyses of the modified design.

The results of the FEM modelling were verified by experiments, including modal analyses. A good correlation was found between the calculated and measured natural frequencies (Fig. 3). Dynamic analyses of the calculations showed that the blades needed to be modified and trimmed to a particular frequency range. After modification all results of the conceptual design phase were discussed with the customer.

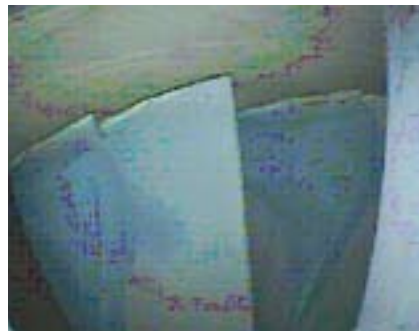
Fig 4: Boroscope inspection after 3000 EOH.

A dedicated boroscope inspection programme was carried out to minimize operational risk as much as possible.
