Overhaul of a 28 MW Austrian-Design Steam Turbine

In October 2003 PT Sulzer Hickham Indonesia received an order to perform an on-site steam turbine overhaul. This 30 Mw unit had been shut down since 1997. The scope of the work was to perform mechanical and electrical inspections, inspect and calibrate controls and get the unit ready to operate at load as soon as possible.

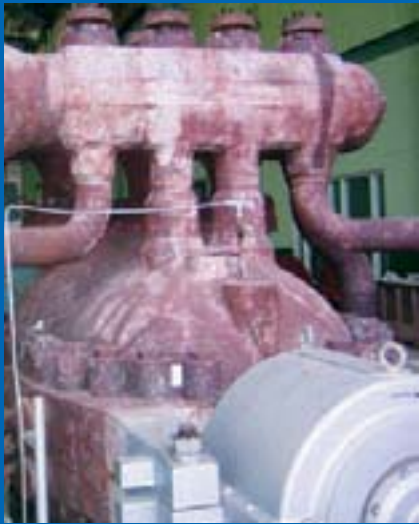
Steam Turbine without insulation

The turbine rotor was removed from the casing, cleaned and NDT inspected. Inspection tooling and equipment was delivered to the site in PT SHI's customized field service container. The equipment stored in the container provides for all typical inspection requirements, including full dimensional inspections and minor repairs. The rotor was found to be sound and was installed and assembled in the casing.

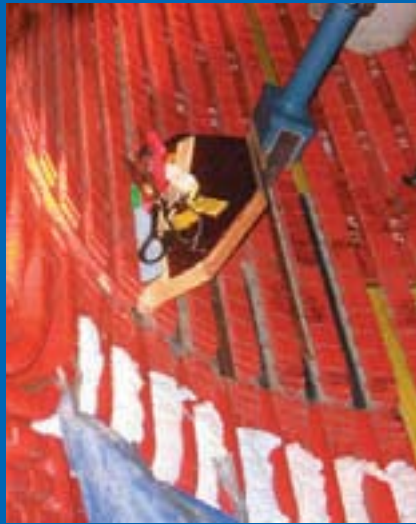
Generator re-wedging.

During testing of the generator it was found that the Polarization index (PI) was well below the standard and that the wedges in the stator were extremely loose. The loose wedges were replaced and the entire unit was cleaned and dried. Upon completion, inspections after the work confirmed that all readings were within specifications.

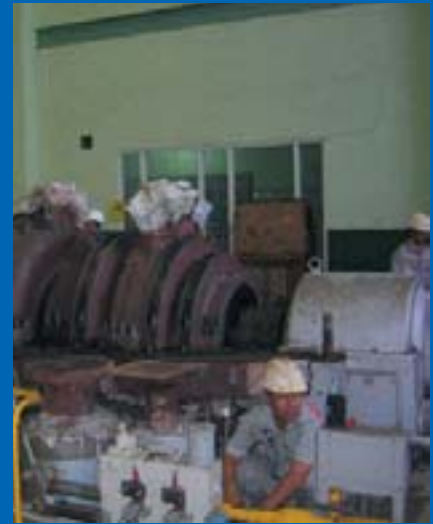
Turbine without case
