Technical Paper

A Sulzer Hickham USA Speciality - Reducing Nitric Acid Plant Downtimes

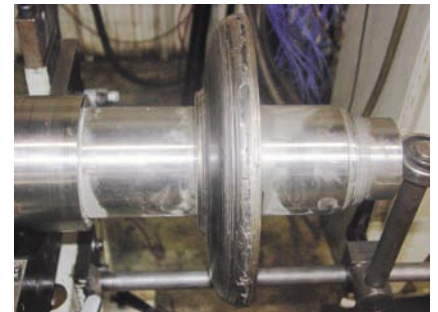
Close-up of rotor thrust collar.

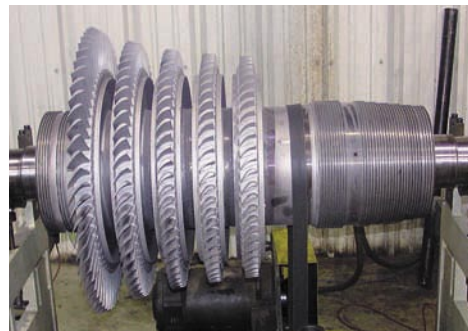
In early August 2006 a chemical plant in the Midwest experienced an unplanned shutdown due to a power failure, which resulted in a lube oil loss to the nitric acid plant compressor train. The lube oil failure caused catastrophic damage to the tail gas expander. Among other critical components, the stator was almost completely destroyed and there was no spare stator readily available. A new replacement stator was months away, so after talking with another Sulzer Hickham USA customer, Sulzer Hickham USA was called on for help. Rather than being without an expander for months, we were able to rebuild the machine to a “better than original” condition with available inventory parts and ship to the customer in only two and a half weeks!

Rotor from wrecked expander.

Sulzer Hickham USA also has the ability to repair these unique machines quicker than anyone else in the industry, partly because of a significant inventory of expander parts. In this particular case, the inventory made all the difference, for it included a complete stator, wheels and blades for this size machine.

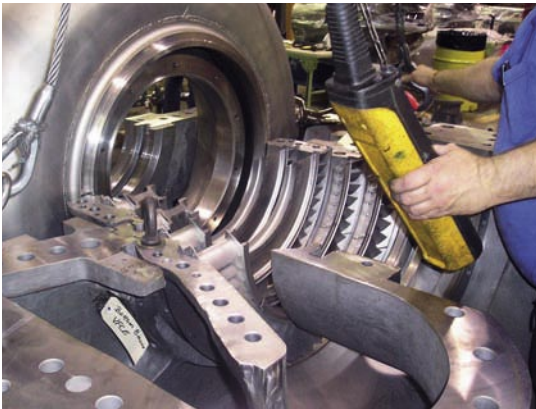
Installed Sulzer Hickham USA inventory stator

The machine was installed and aligned to Sulzer Hickham USA specifications. Upon startup, the customer

proudly stated that the vibrations and air leakage from the HP seal were lower than they had ever experienced, even when the machine was new.

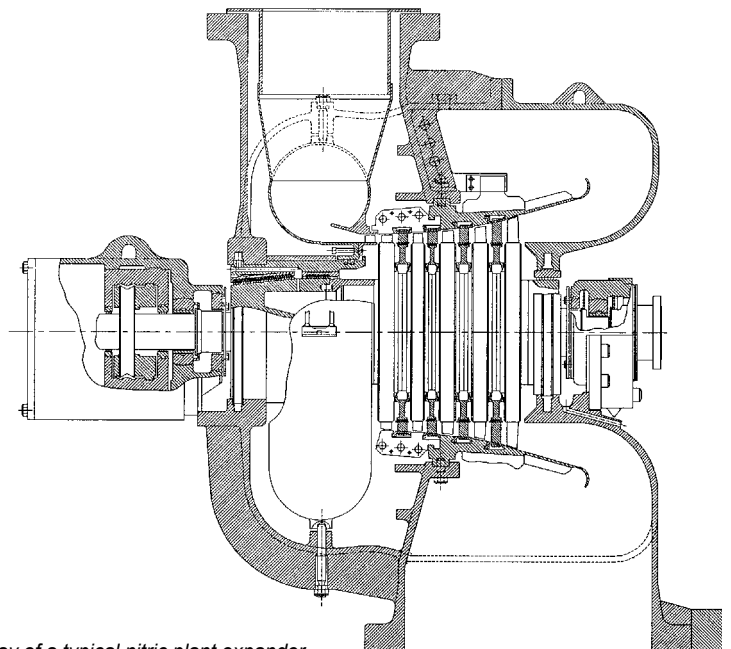
Cutaway of a typical nitric plant expander.

These nitric acid expanders are unique in design due to the large thermal variations that the machine is exposed to. Unlike the average steam turbine and centrifugal compressor, small deviations from tolerance during the repair procedures cannot be allowed, for the design is very unforgiving. Sulzer Hickham USA has developed standardized repair procedures to assure a well performing machine in the field. Over the years we have also initiated several design improvements proven to increase reliability and provide lower vibration on these machines.
