## Design Change Takes Care of Repeated Tie Wire Cracking on a 19 MW-Steam Turbine

**Four failures and three previous modifications convinced the owner of this 19 MW-steam turbine, located at a waste power plant, that a radical design change, based on thorough analysis, was required to solve the recurrent problems and this was achieved by blade modification.**

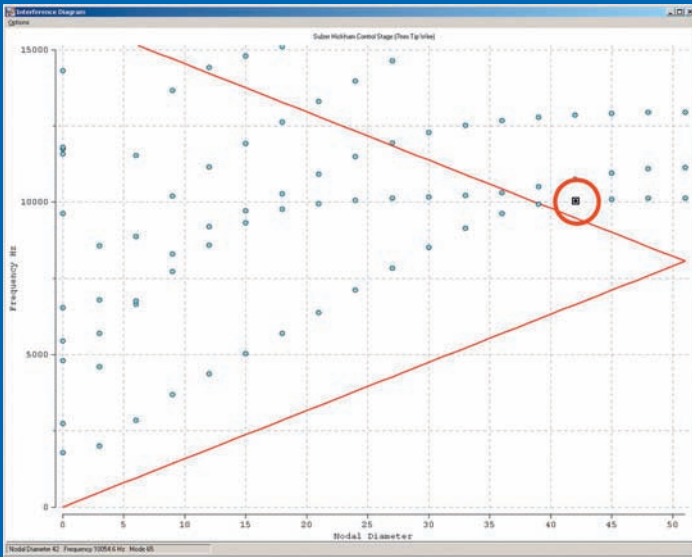
Figure 1: Interference diagram for the original design; the dominant failure mode is outlined.

The stresses occurring were computed, taking into account the specific operational conditions, such as speed, nozzle configuration and steam conditions. As shown in the interference diagram (Figure 1) the dominant failure mode found for the original shroud design is a resonant condition of the tangential mode with the nozzle passing frequency.

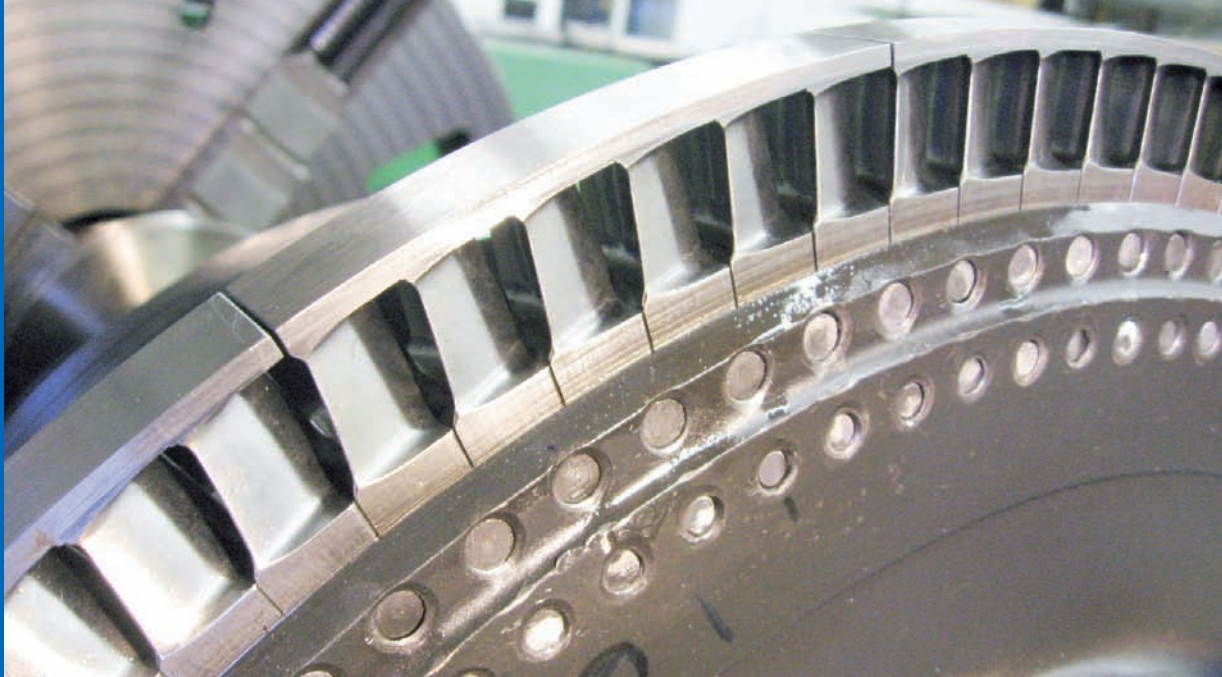
Re-engineered blades.

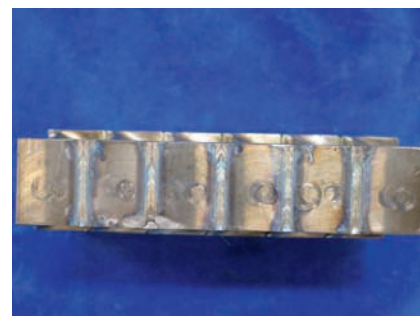
Figure 5: Blade packets after welding.

To guarantee sound dimensions and minimize distortion, dedicated tooling was constructed together with Sulzer Repco. The outer shrouds of 6 blades were welded by laser welding as indicated in Figure 5. The depth of the through weld was 5 mm.

After welding, the parts were heat treated and inspected by crack inspections and X-ray. No defects were found.
