Demonstration of Sulzer Repco's Dedication to Their Customers' "Need for Speed"

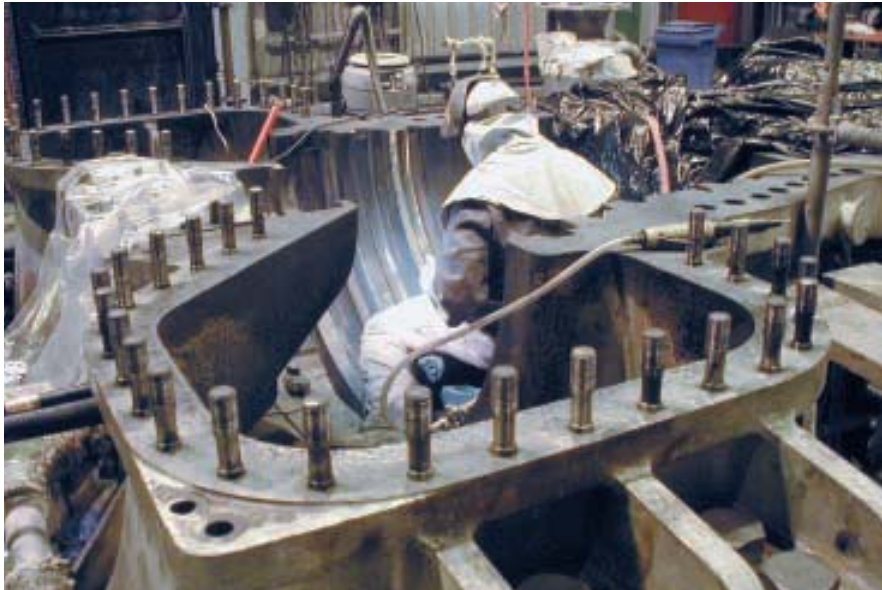
Weld repair to steam turbine in the under casing

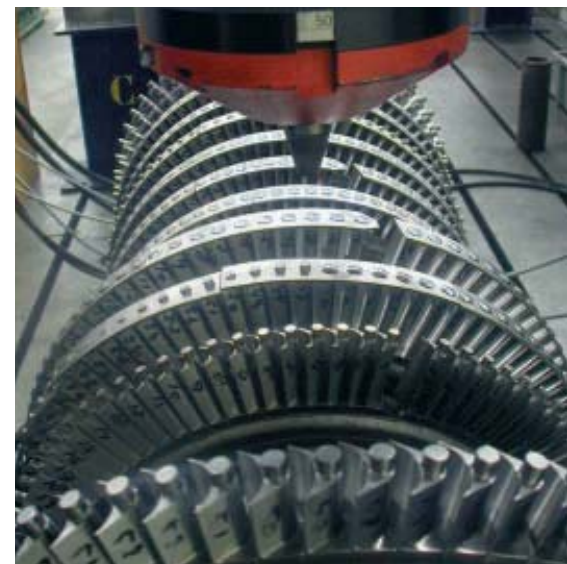
Riveting of a steam turbine rotor

One of Sulzer Repco's customers was half way through the revision of a steam turbine when confronted with severe erosion on the last row of blades. According to OEM specifications these blades had to be renewed. The OEM estimated the delivery time for the new blades at about fourteen weeks. To help this customer, Sulzer Repco repaired the blades by means of welding and re-profiling within two weeks. The revision was successfully completed within the available time frame.
