# Technical Paper

## Major Overhaul of a 60 MW Steam Turbine - Generator and Balance of Plant at a Geothermal Power Plant

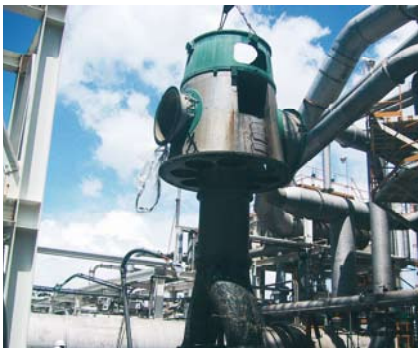
*Hot well pump removal for overhaul*

One of the two hot well pump units was also transported to the workshop for a complete overhaul. While the rotor repair was ongoing in the workshop, the site crew continued the major overhaul work on the balance of the plant, i.e. rock muffler, various valves, steam purifier installation, generator unit, condenser, various pumps and motors, and ejectors complete with all electrical and instrumentation to be checked, calibrated and tested. On the cooling tower, two cells of air drifted fillers were removed and replaced with new incoming cells

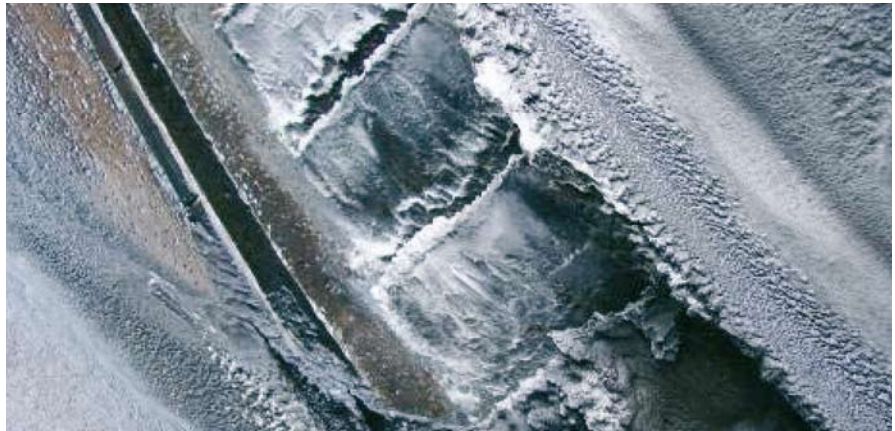
*Hard scale deposit behind turbine inlet nozzle*

containing corrosive gasses for long periods of time. Hard scale deposits are frequently found during casing

opening, in addition to erosion/corrosion problem of the steam path parts, i.e. nozzles, diaphragms, blades.

Several borescope inspections had been performed to determine the steam turbine rotor condition prior to performing major overhaul. The main scope of work for the shop repair comprised blade replacement of the 1st, 2nd and 3rd stages of both Drive End and Non-Drive End and welding repair of nozzle and diaphragms

stage 1 to 3 of both sides. High metal spots and dents in the coupling holes required in-situ reaming to repair the coupling bolt holes in addition to finish grinding of new replacement coupling bolts.

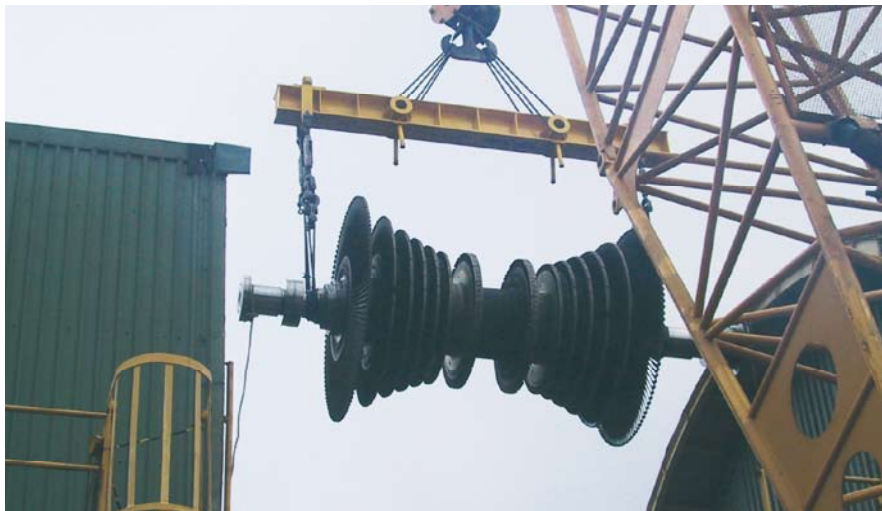
*Removing rotor from casing*

Two large mobile cranes - 150 ton and 45 ton were specially requested and transported to site. The Sulzer Hickham, Indonesia crew and tool containers, office and storages were mobilized to site prior to plant shut down. It took five working days to prepare the steam turbine rotor for lifting from the casing. The rotor was packaged into a container and secured prior to transporting to the workshops for the scheduled 60 days repair period.

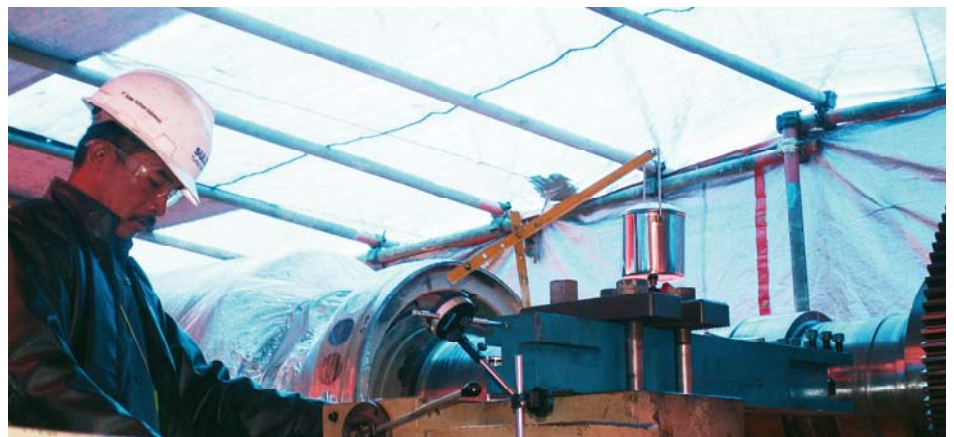
*In-situ machining*

rotor with enough heating during the inspection period. The rainy season with frequent hard rain, storms and damp conditions were an additional challenge for the team on site. During the generator rotor inspection, it was found that the oil seal areas and exciter ring has undergone significant

radial rubbing which require machining repair, preferably on site. This was another challenge for TSID to perform in situ machining. A special team for in situ machining was mobilized. The activities included surface leveling of soil, setting up turning device, V-block support platform and under-carriage of lathe machine. The generator rotor was reassembled after a final inspection was performed.
